**Flood Control Project Maintenance**  
**2018 Structure Summary Report**  
**Overall Unit and Item Ratings**

**Merced Streams Group**

**Black Rascal Creek Drop Structure**

**Owens Creek Siphon Structure**

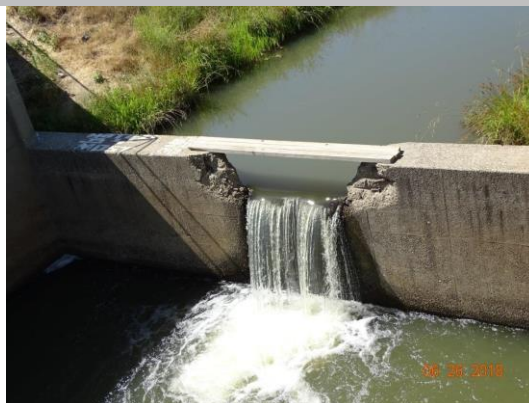
Photo 1 of 5 : ST\_2018\_NA0013\_28\_1\_20180802\_00007.jpg

View of drop structure from downstream. Summer 2018

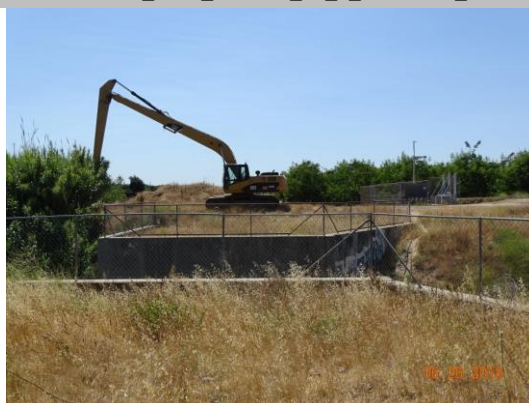
Photo 2 of 5 : ST\_2018\_NA0013\_28\_1\_20180802\_00008.jpg

View of abutments from left bank. Summer 2018

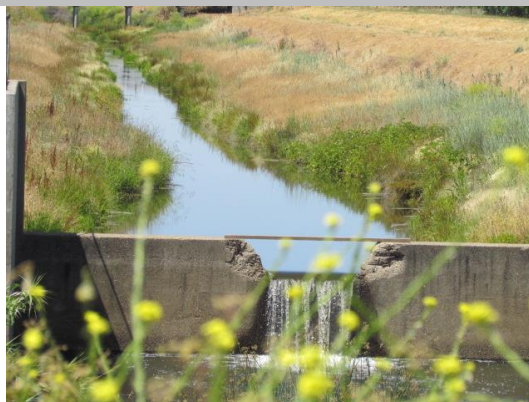
Photo 3 of 5 : ST\_2018\_NA0013\_28\_1\_20180608\_00001.jpg

Black Rascal Creek Drop Structure viewed from across channel.  
Summer 2017

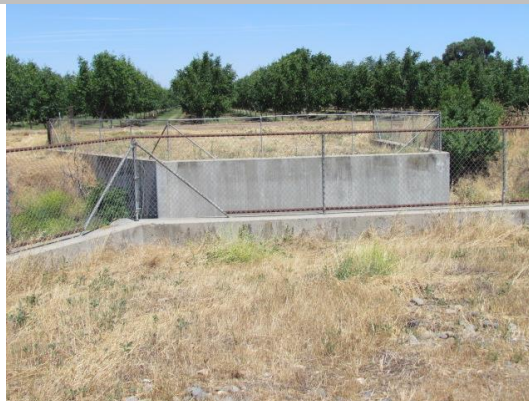
Photo 4 of 5 : ST\_2018\_NA0013\_28\_1\_20180608\_00002.jpg

Looking across from the left bank abutment over to the right bank.  
Summer 2017

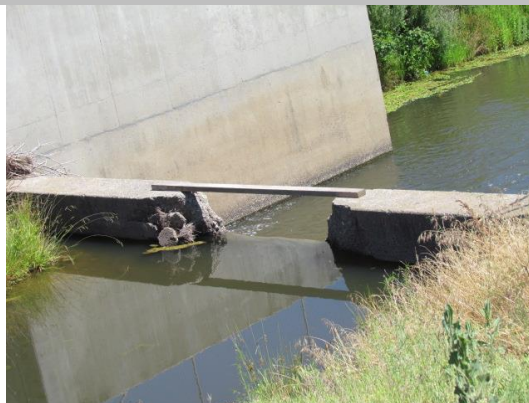
Photo 5 of 5 : ST\_2018\_NA0013\_28\_1\_20180608\_00003.jpg

Black Rascal Creek Drop Structure view of the upstream side of the outlet. Summer 2017

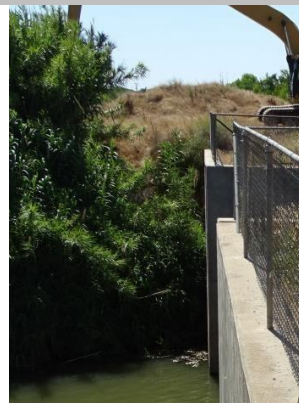
Photo 1 of 3 : ST\_2018\_NA0013\_28\_2\_20180802\_00009.jpg

LM Start	0.00	Rating **	A	Issue No.	2
LM End	0.00	Issue Type +	Ma	Location *	
Category	Structures & Concrete Lined Channels			GPS Latitude/Longitude	
				Start	End
Item	Vegetation & Obstructions			37.314667 °	37.314667 °
				-120.396101 °	-120.396101 °
DWR ID	DWR_NA0013_28_t_2016_2				
Action/Comments					
Inspector Comments: Remove Arundo on the right bank downstream of the structure.

View of Arundo on right bank downstream of structure. Summer 2018

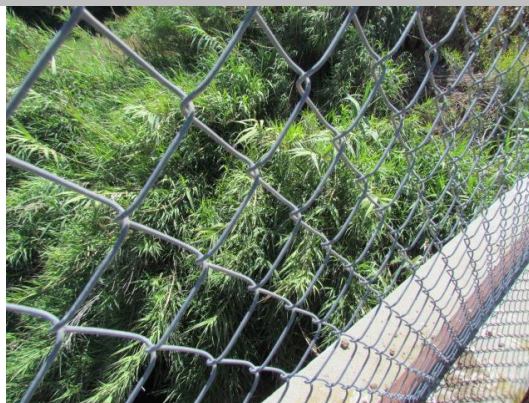
Photo 2 of 3 : ST\_2018\_NA0013\_28\_2\_20180608\_00004.jpg

LM Start	0.00	Rating **	A	Issue No.	2 (cont)	
LM End	0.00	Issue Type +	Ma	Location *		
Category	Structures & Concrete Lined Channels			GPS Latitude/Longitude		
				Start	End	
Item	Vegetation & Obstructions			37.314667 °	37.314667 °	
				-120.396101 °	-120.396101 °	
DWR ID	DWR_NA0013_28_t_2016_2					
Action/Comments						
Inspector Comments: Remove Arundo on the right bank downstream of the structure.

Standing on the right bank looking downstream at wild bamboo growth against the concrete structure. Summer 2017

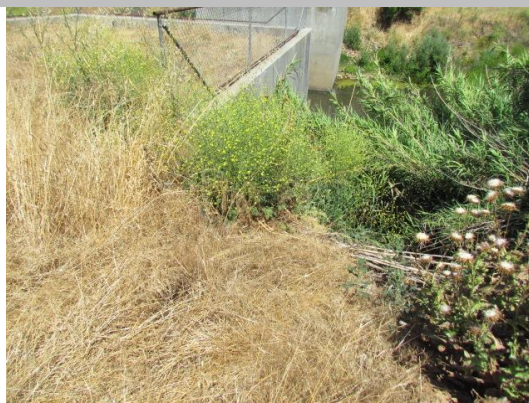
Photo 3 of 3 : ST\_2018\_NA0013\_28\_2\_20180608\_00005.jpg

Standing downstream of the right bank bamboo and other wild growth present against the concrete wall. Summer 2017

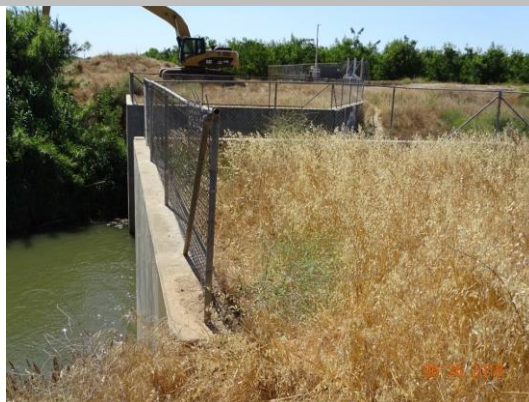
Photo 1 of 2 : ST\_2018\_NA0013\_28\_23\_20180802\_00011.jpg

View of fence along left bank. Summer 2018

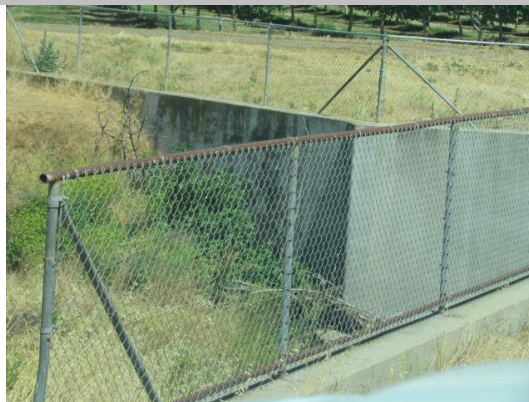
Photo 2 of 2 : ST\_2018\_NA0013\_28\_23\_20180608\_00006.jpg

View of safety fence looking from the right bank across the channel to the fence on top of structure left bank. Summer 2017

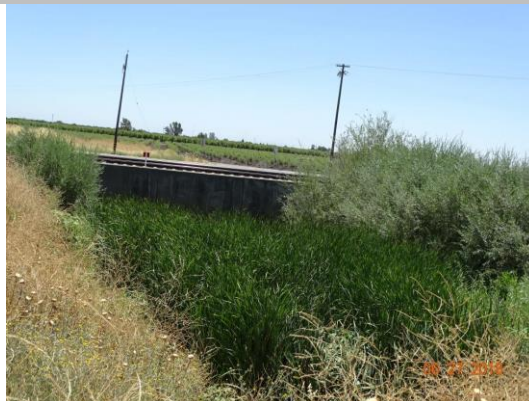
Photo 1 of 6 : ST\_2018\_NA0013\_51\_1\_20180802\_00007.jpg

View of siphon inlet structure. Summer 2018

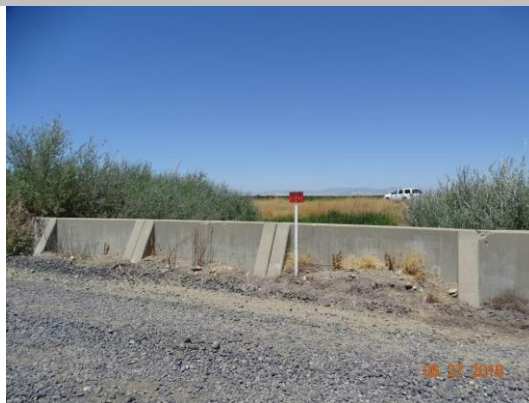
Photo 2 of 6 : ST\_2018\_NA0013\_51\_1\_20180802\_00008.jpg

View of top of siphon inlet structure. Summer 2018

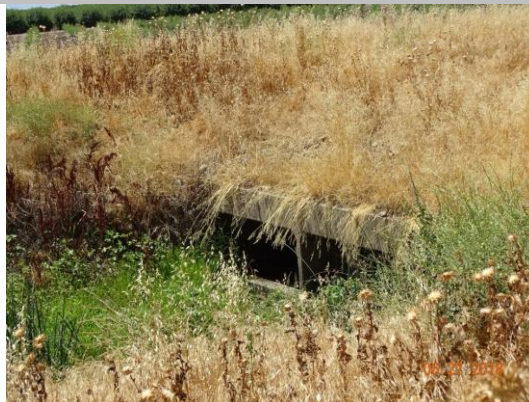
Photo 3 of 6 : ST\_2018\_NA0013\_51\_1\_20180802\_00009.jpg

View of the outlet of the siphon structure. Summer 2018

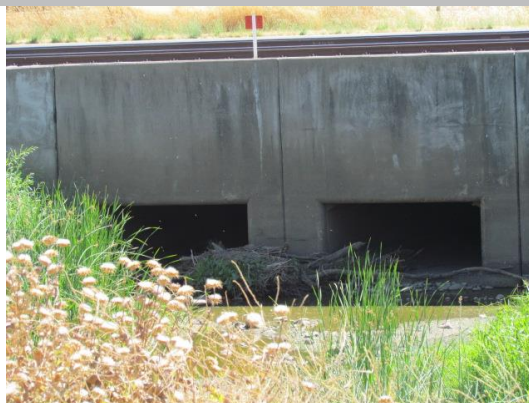
Photo 4 of 6 : ST\_2018\_NA0013\_51\_1\_20180608\_00001.jpg

Looking at the inlet structure from left bank. Owens Creek Siphon Structure. Summer 2017

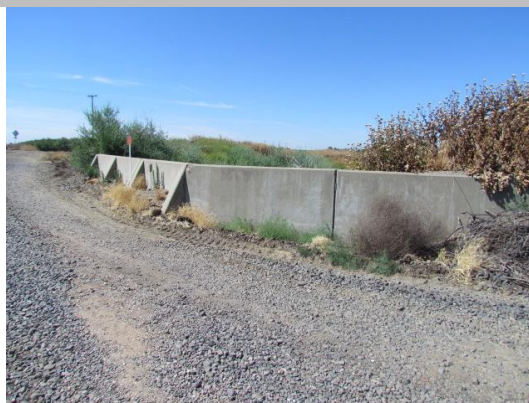
Photo 5 of 6 : ST\_2018\_NA0013\_51\_1\_20180608\_00002.jpg

Top of Owens Creek Siphon Structure Inlet. Summer 2017

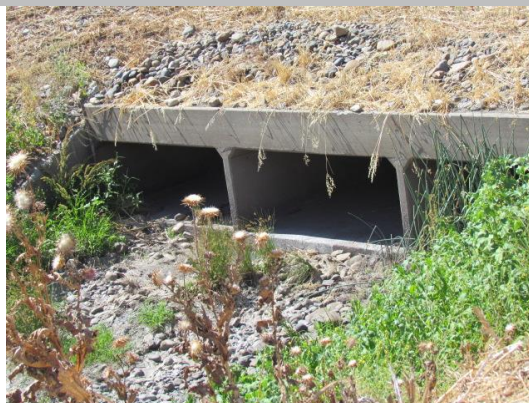
Photo 6 of 6 : ST\_2018\_NA0013\_51\_1\_20180608\_00003.jpg

Looking at the outlet of the Owens Creek Siphon Structure. Summer 2017

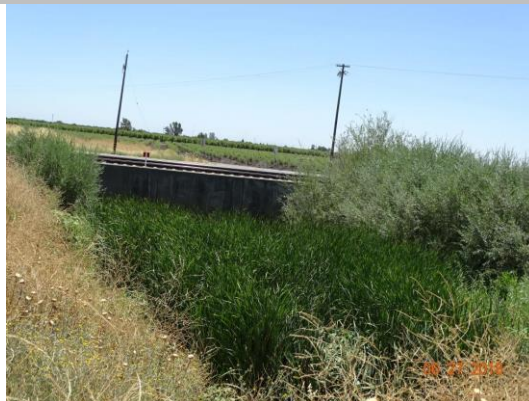
Photo 1 of 4 : ST\_2018\_NA0013\_51\_2\_20180802\_00010.jpg

LM Start	0.00	Rating **	U	Issue No.	2
LM End	0.00	Issue Type +	Ma	Location *	
Category	Structures & Concrete Lined Channels			GPS Latitude/Longitude	
				Start	End
Item	Vegetation & Obstructions			37.262648 °	37.262648 °
				-120.288194 °	-120.288194 °
DWR ID	DWR_NA0013_51_t_2016_2				
Action/Comments					
Inspector Comments: Control the vegetation growth at the inlet of the siphon structure which may impede flows. Summer 2018

View of vegetation obstructing view of inlet. Summer 2018

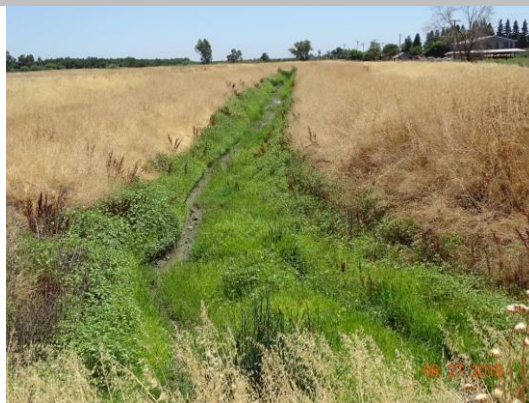
Photo 2 of 4 : ST\_2018\_NA0013\_51\_2\_20180802\_00011.jpg

View of vegetation downstream of siphon structure. Summer 2018

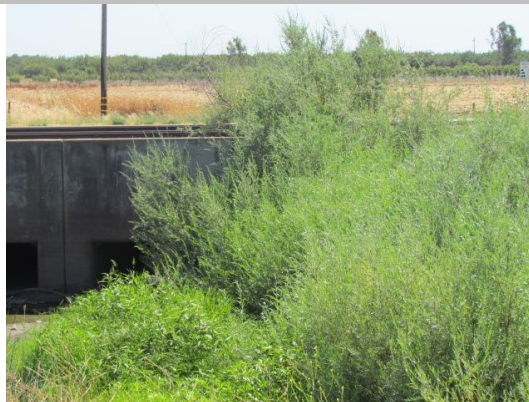
Photo 3 of 4 : ST\_2018\_NA0013\_51\_2\_20180608\_00005.jpg

Looking at the vegetation present on the right bank of the inlet. Summer 2017

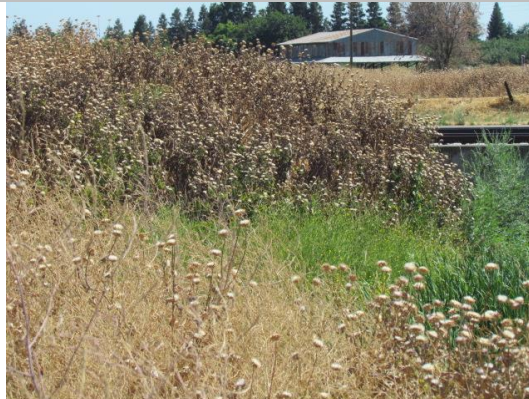
Photo 4 of 4 : ST\_2018\_NA0013\_51\_2\_20180608\_00004.jpg

LM Start	0.00	Rating **	U	Issue No.	2 (cont)	
LM End	0.00	Issue Type +	Ma	Location *		
Category	Structures & Concrete Lined Channels			GPS Latitude/Longitude		
				Start		End
Item	Vegetation & Obstructions			37.262648 °		37.262648 °
				-120.288194 °		-120.288194 °
DWR ID	DWR_NA0013_51_t_2016_2					
Action/Comments						
Inspector Comments: Control the vegetation growth at the inlet of the siphon structure which may impede flows. Summer 2018

Looking at the vegetation present on the left bank if the inlet. Summer 2017

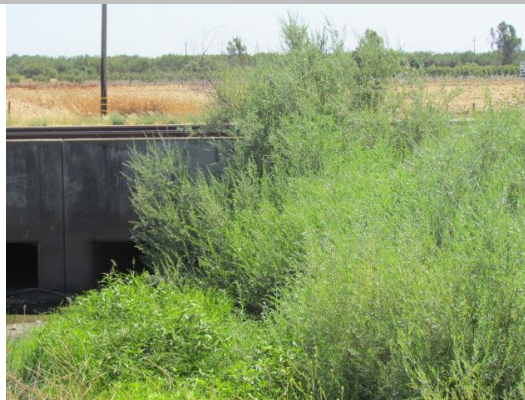
Photo 1 of 1 : ST\_2018\_NA0013\_51\_7\_20180608\_00006.jpg

Looking at the inlet from the left bank upstream. Summer 2017
